ABM: Challenges with National Register Listing and HTC Approval

National Register Listing

Historic Tax Credit Approvals

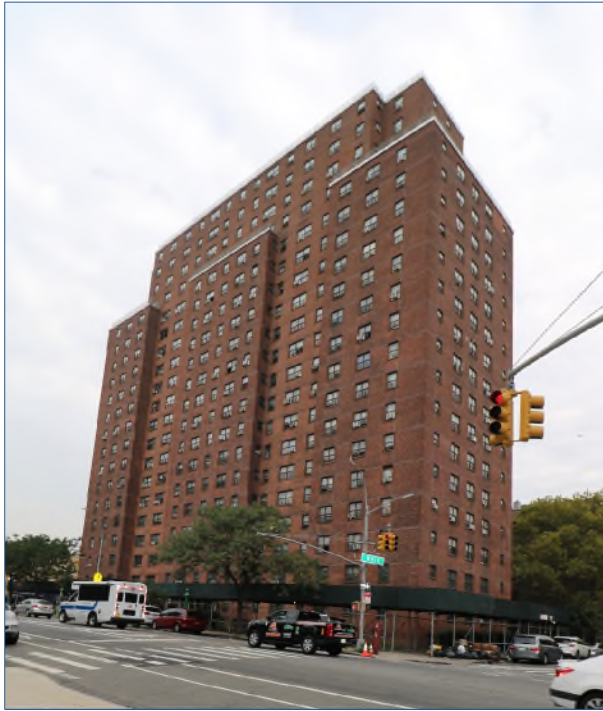
Audubon Houses, 1962

LISTING STRATEGY: AUDUBON HOUSES

- Built 1962
- **POLITICS/GOVERNMENT:** representative and intact example of early vest pocket housing (first vest pocket to be completed)

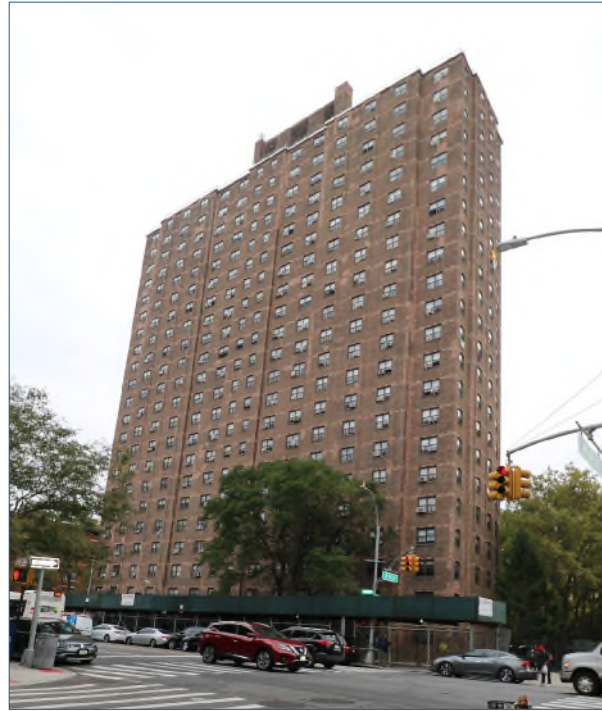
Bethune Houses, 1967

LISTING STRATEGY: BETHUNE HOUSES

- Built 1967
- **POLITICS/GOVERNMENT:** representative and intact example of federally funded senior high rise (also vest pocket, but significant for senior housing)

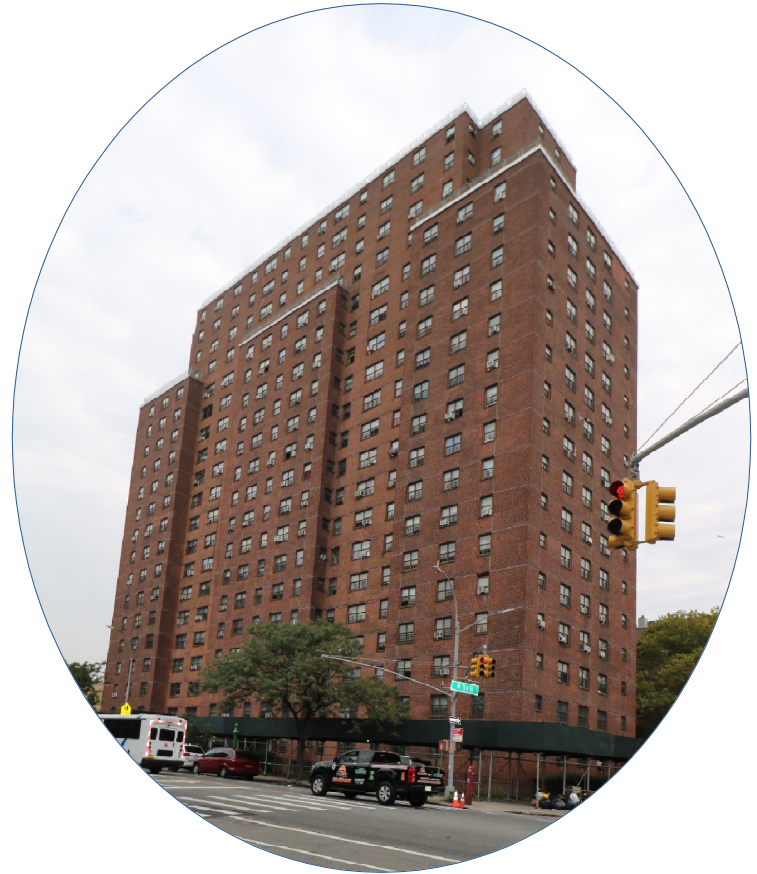
AUDUBON HOUSES – PRIMARY CHALLENGES

- Lobby Circulation and Finishes
- Corridor Finishes

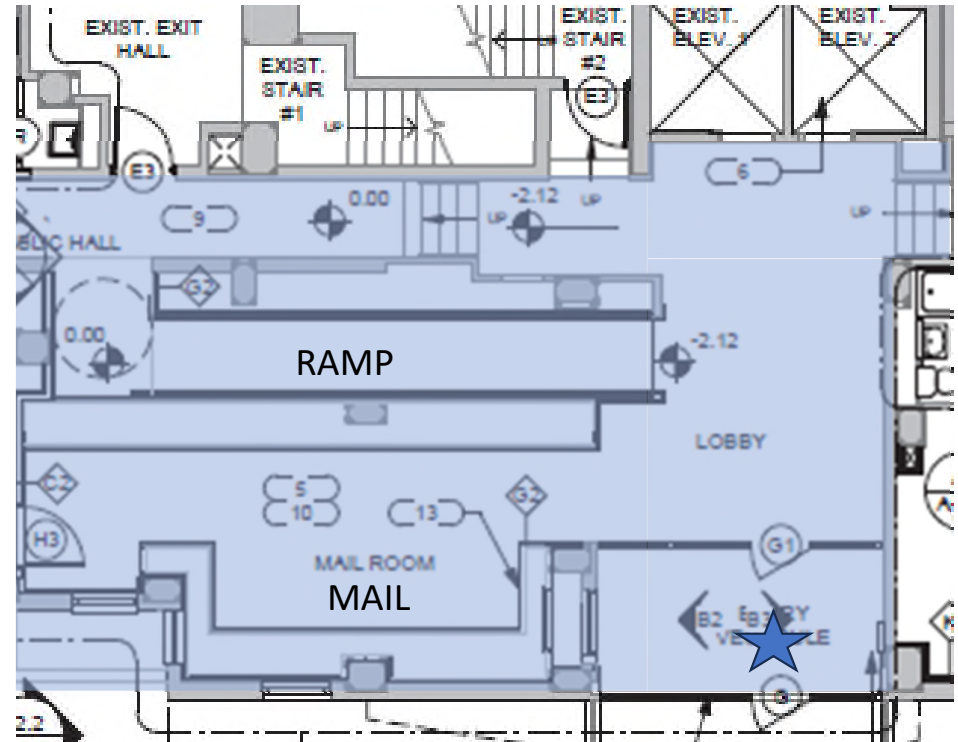
Post-Rehab

- Added vestibule (replicates historic condition)
- Expanded lobby size
- Added ramp
- Expanded mailroom and added modern mailboxes

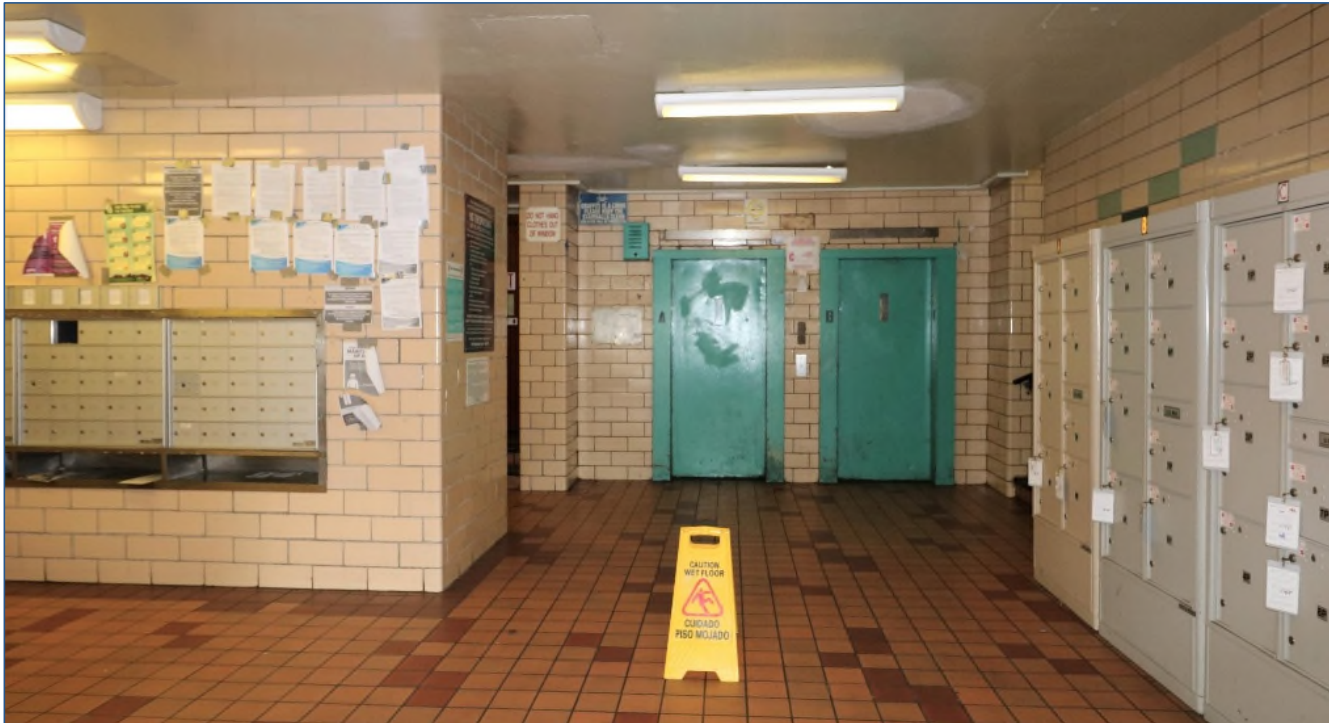
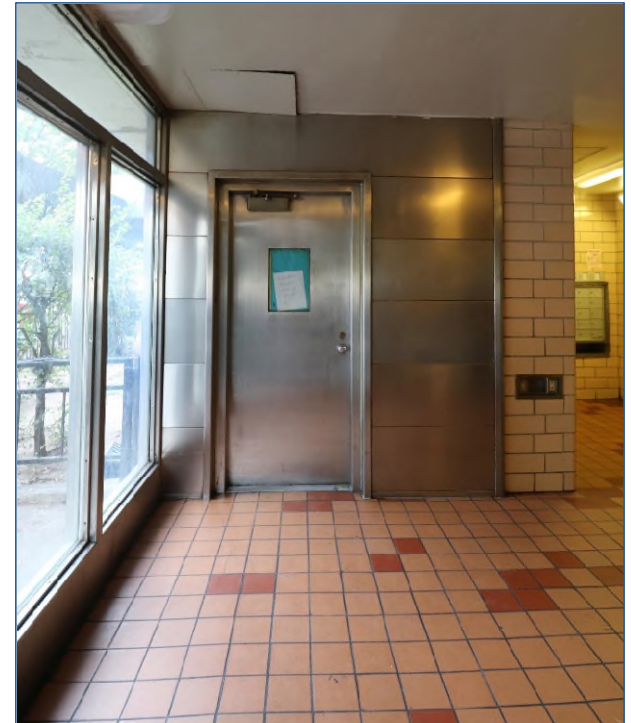
Pre-Rehab

- Floor tile not historic; historic wall tile
- Dated color scheme
- Dimly lit
- Outdated mailboxes

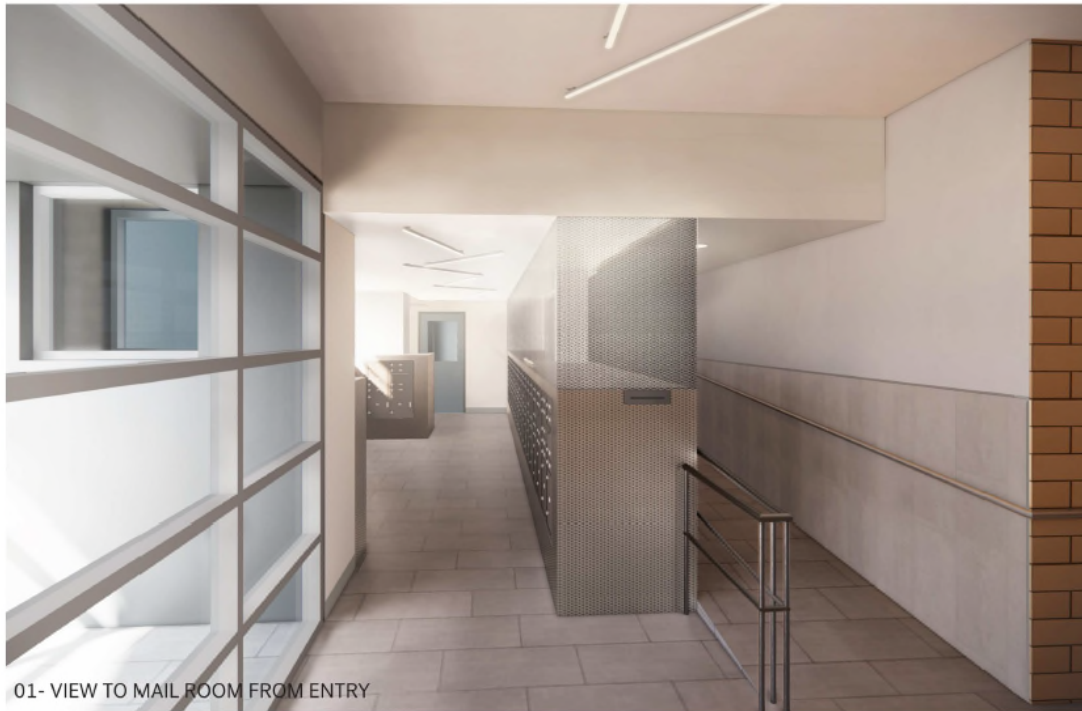
01- VIEW TO MAIL ROOM FROM ENTRY

- New floor tile (pre-rehab was not historic)
- Retain tile on walls
- Modern color scheme
- Bright, modern lighting
- Modern mailboxes

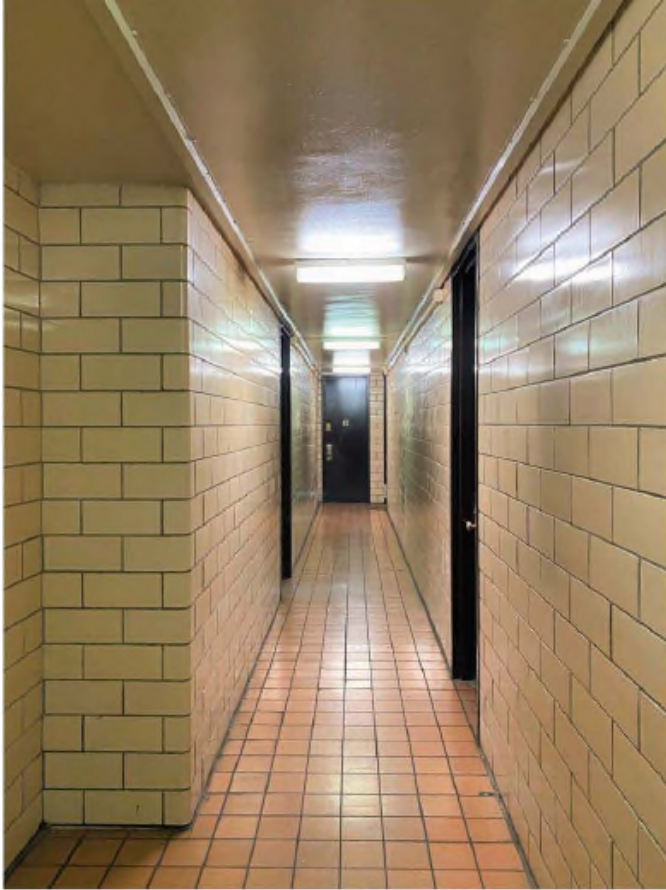
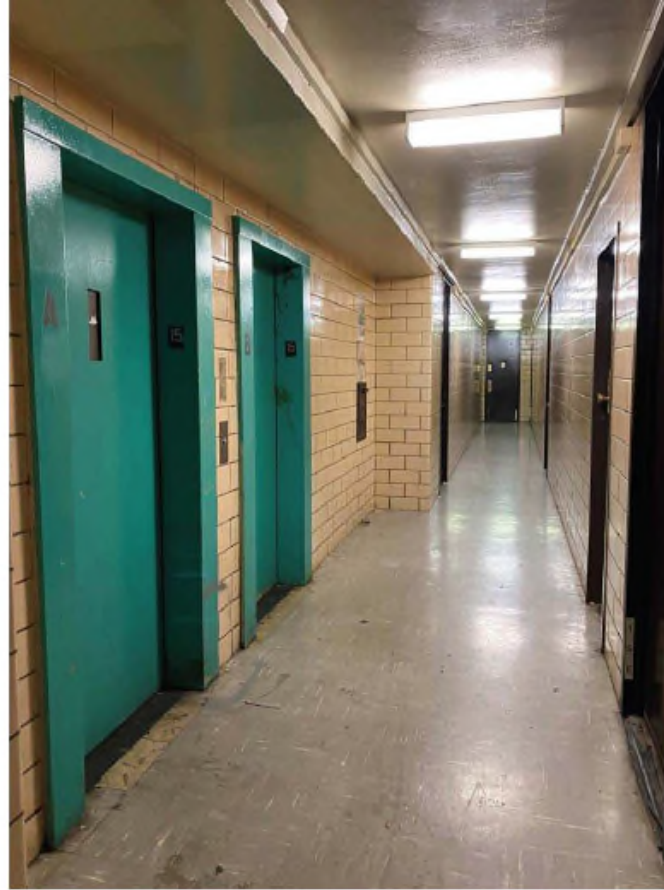
Pre-Rehab

- Non-historic floor tile
- Historic wall tile
- Dated color scheme
- Dimly lit

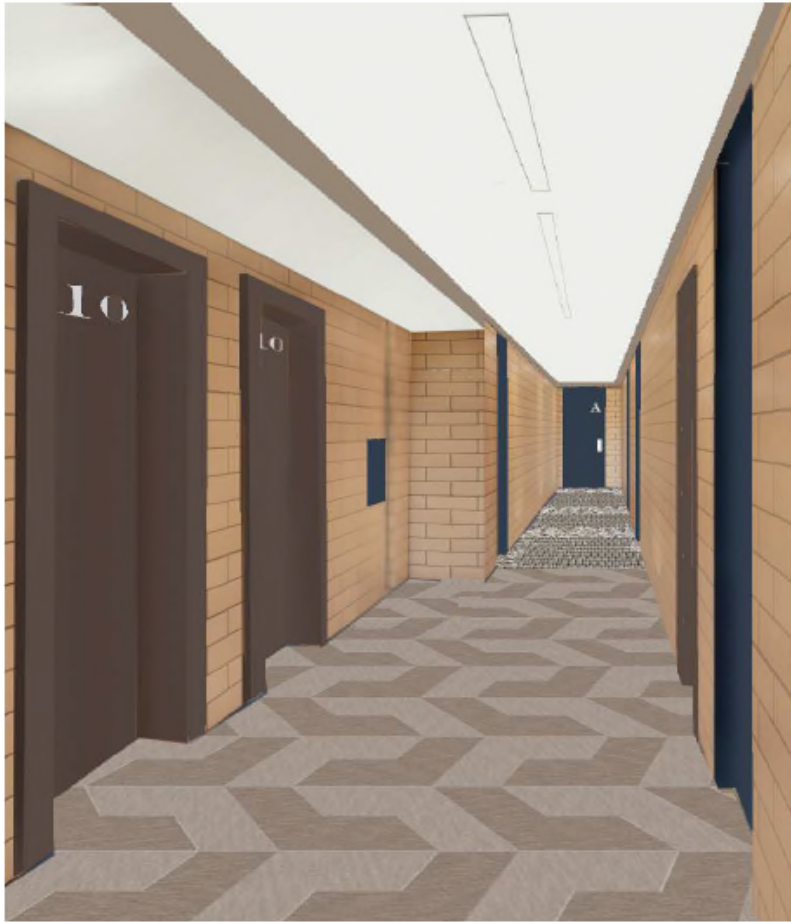
Post-Rehab Rendering

- New floor tile (pre-rehab was not historic)
- Retained historic tile at walls
- Improved color scheme
- Bright, modern lighting

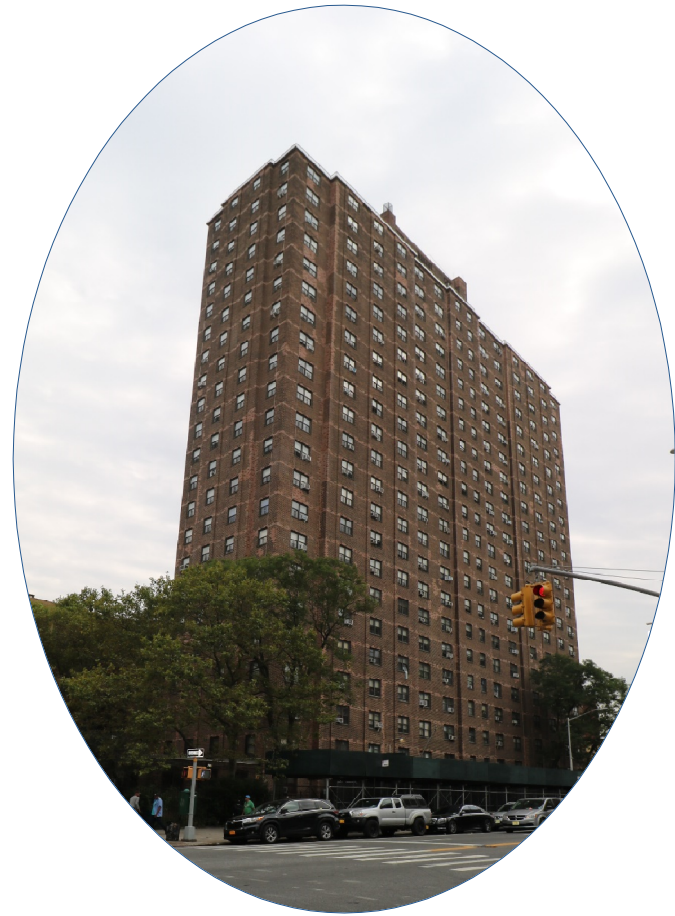
BETHUNE HOUSES – PRIMARY CHALLENGES

- Lobby Circulation and Finishes
- Corridor Finishes

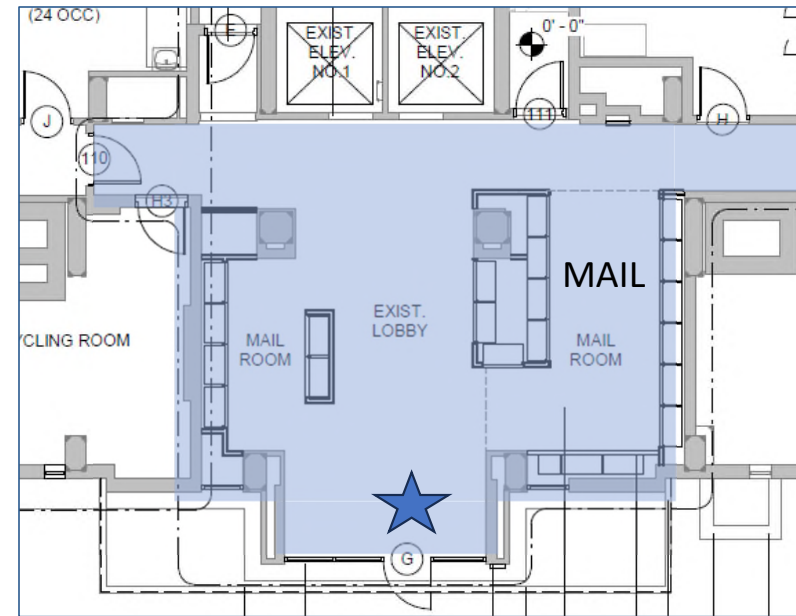
Post-Rehab

- Vestibule not permitted (no historic evidence)
- Expansion of lobby not necessary
- Improved circulation at mail room (floating island)
- Modern mailboxes

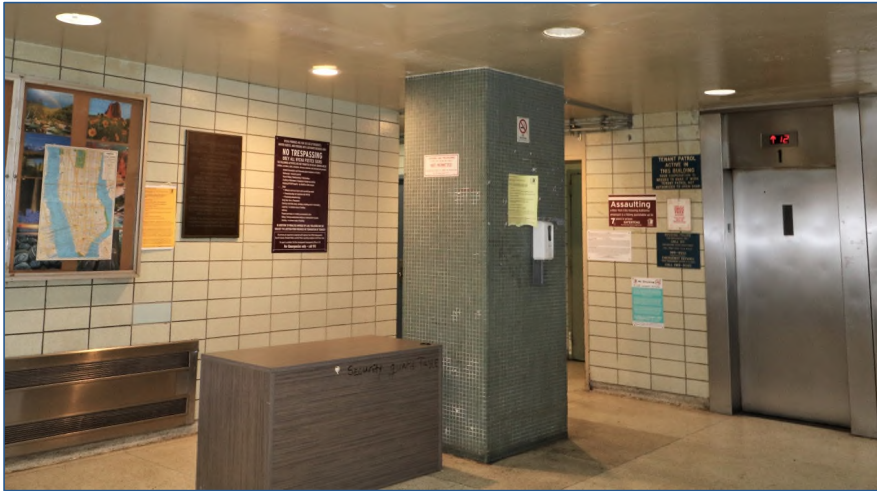
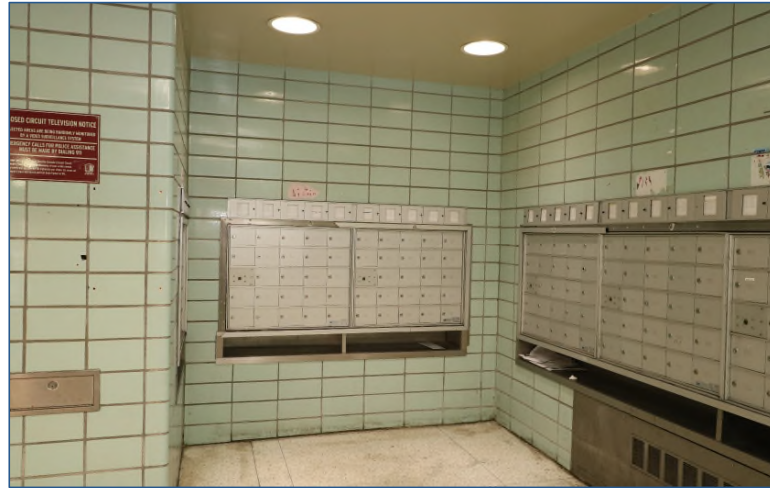
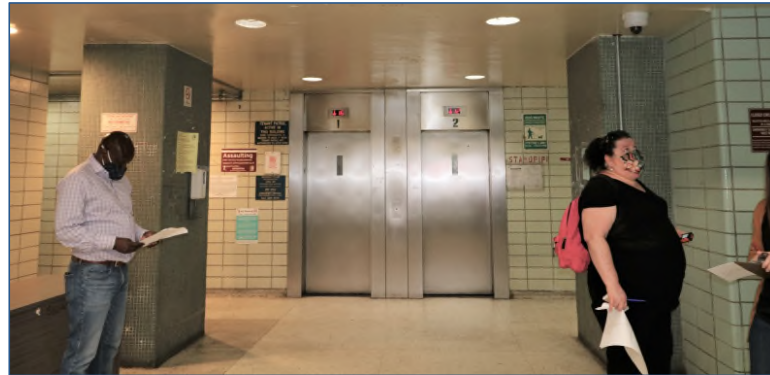
Pre-Rehab

- Historic terrazzo floor
- Historic wall/column tile
- Dated color scheme
- Dimly lit
- Tight mail room with outdated mailboxes

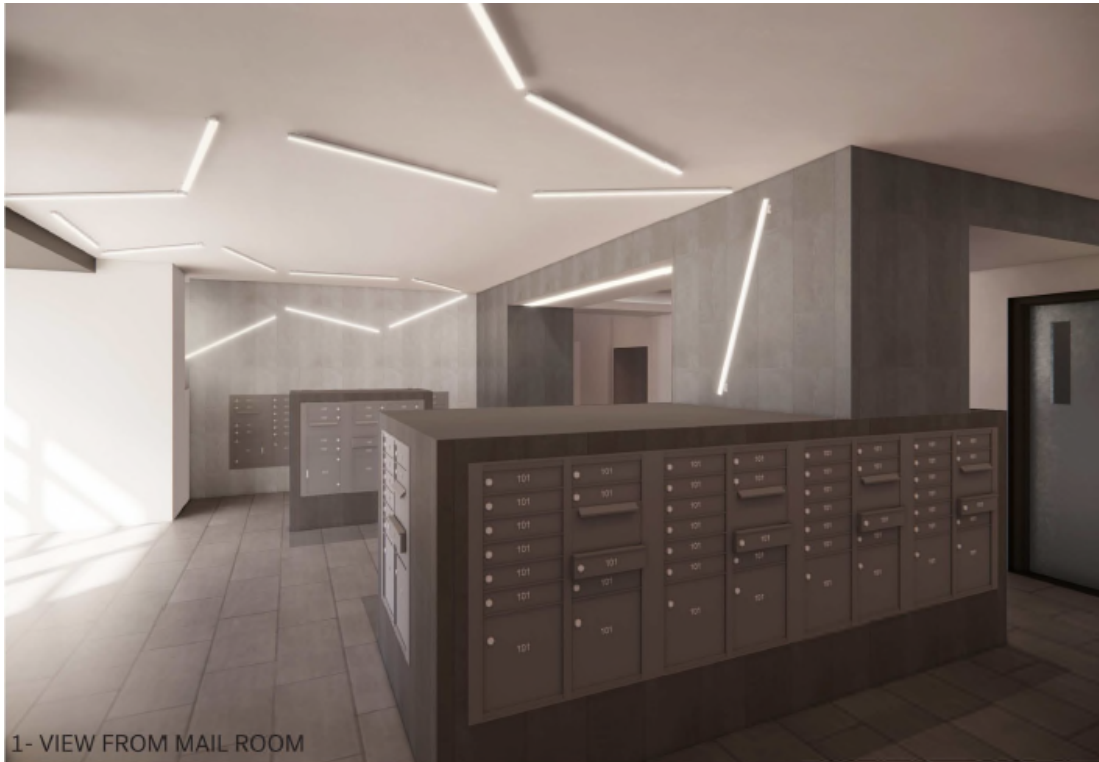
1- VIEW FROM MAIL ROOM

Proposed Post-Rehab Rendering (not entirely approved)

- Retained historic terrazzo floor
- Retained historic wall/column tile in most areas
- Modern, brighter lighting
- Improved circulation at mail room with modern mailboxes

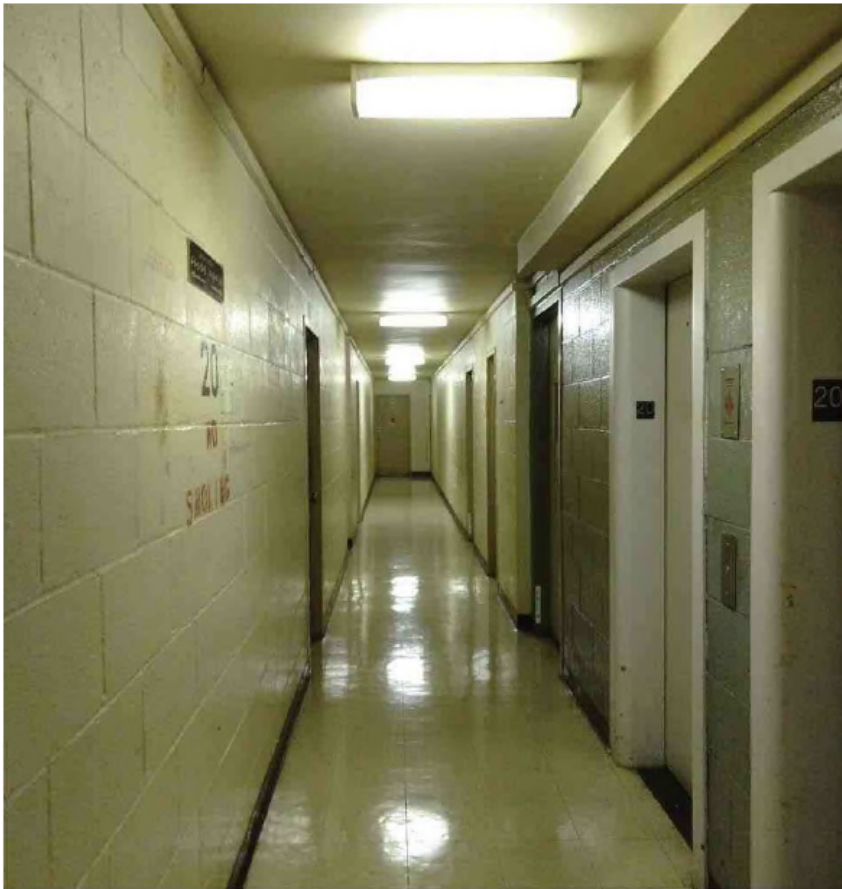
Pre-Rehab

- Modern floor tile
- Historic painted CMU walls
- Dated color scheme
- Dimly lit

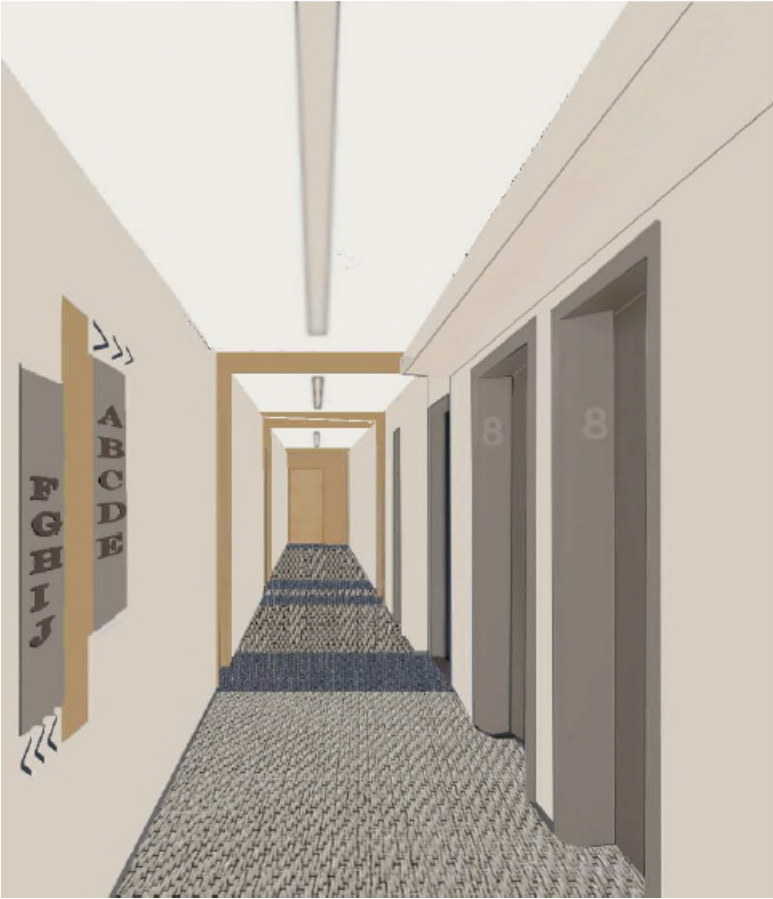
Proposed Post-Rehab Rendering (not approved)

- Proposed carpet not approved; required to use tile
- Retain historic painted CMU walls
- Improved color scheme
- Bright, modern lighting
